Safety Management of Shutdown Facilities

Facility Conditions

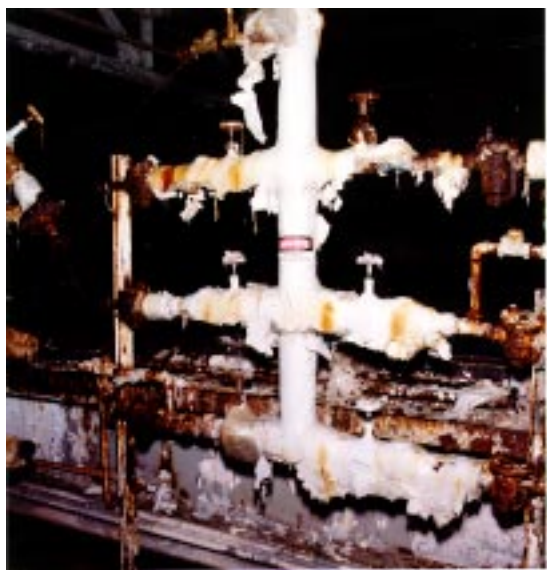
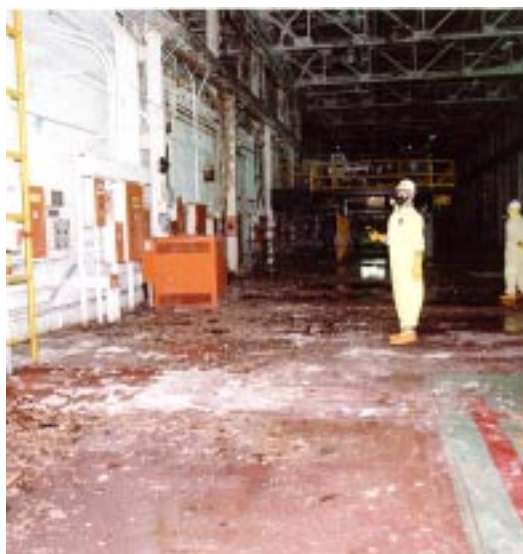
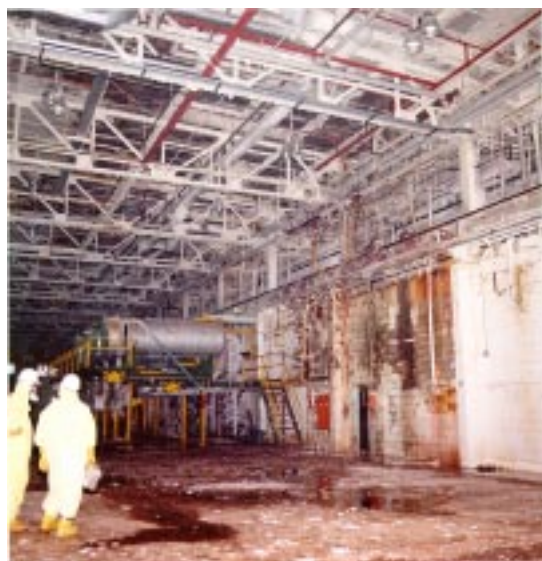
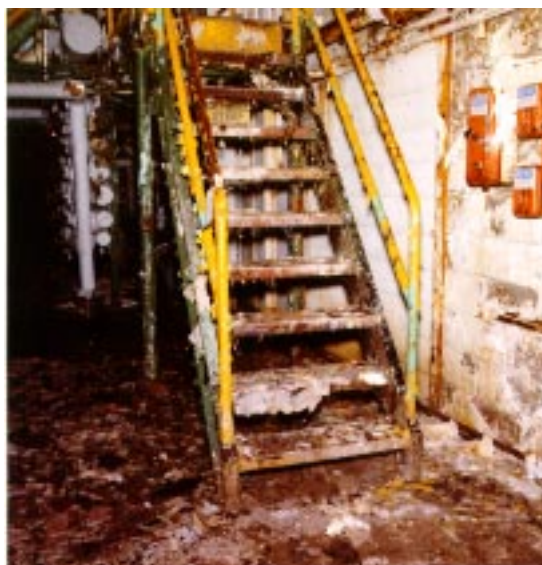
Facility Conditions in June 1997

The current conditions in K-1131 are not conducive to safety and are deteriorating rapidly, as demonstrated by the photographs taken in conjunction with a tour by review team personnel, shown on the next page. The roof is leaking severely and its structural integrity is degraded, resulting in ceiling panels and other debris falling from the ceiling. On the day of the Oversight tour, rainwater showered down into large areas of the facility, contributing to significant amounts of standing water. Radioactive contamination, asbestos, lead-based paint, and lubrication oil have washed down and accumulated on the floor in standing water due to the intentionally plugged floor drains. A stairway was indicated by escorts to be unsafe but lacked barriers or warning signs. Chemical tanks in this building were believed to be empty but were not labeled “empty” as required. Various penetrations in the outer walls are potential release paths.

The contaminated water poses a potential threat to groundwater from water pathways (e.g., leaks out uncontrolled penetrations in buildings). In addition, rapidly degrading building structures increase worker safety hazards (e.g., slippery conditions, falling roof panels, structurally-degrading stairways, radiological contamination, and loose asbestos) for personnel who enter the facility, even with proper protective clothing.

Longstanding facility degradation has been accelerated since the process facility was placed in abandon-in-place status, and maintenance stopped.

in abandon-in-place status (without completely stabilizing the facility) have significantly accelerated degradation of this facility over the past three years. The degradation is evident in comparing photographs taken three years ago with those taken during the Oversight review.

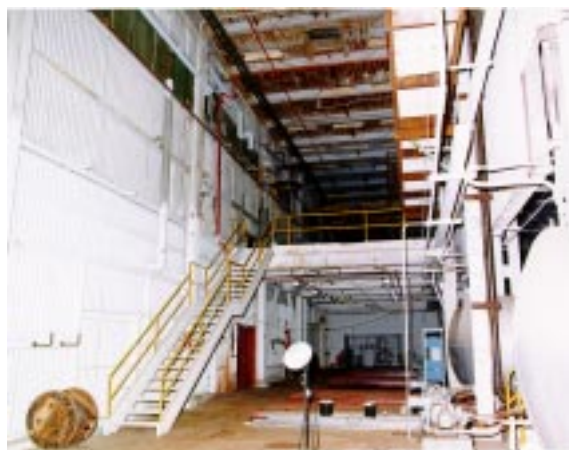
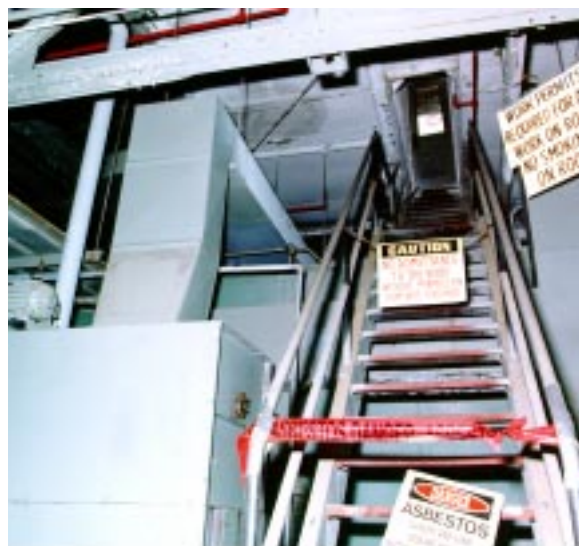
Facility Conditions in 1994

- **1994** The roof deteriorated to the point that it needed to be replaced. An installation specification was issued. The interior of the building had noticeably degraded due to the leaking roof.

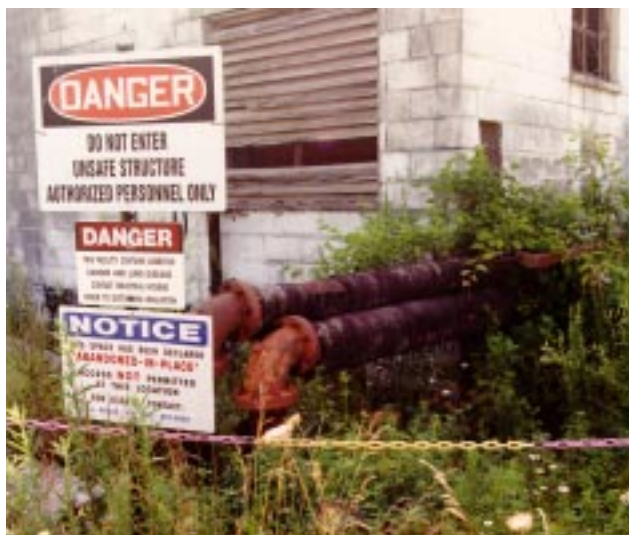
Conditions at Building K-725 in June 1997

Building K-725. Conditions in Building K-725, which has been shut down and essentially abandoned for nearly 40 years, are reported to be even worse than K-1131. K-725 was a machine shop that still has beryllium deposits in the ventilation ducts. The building is in an advanced state of degradation (see photos). The walls are crumbling, a tree is growing

between the building wall and a ventilation duct, weeds and vines are growing over the structures, windows are gone, the roof is degraded, and the entire area is roped off and fenced as radiologically contaminated. Conditions are such that access to this facility has been prohibited for any reason (including annual surveillance). With beryllium in the duct work, mercury, radiological and asbestos contamination, and a significantly degraded structural condition, this building represents a substantial challenge to eventual decontamination and decommissioning efforts and environmental restoration.

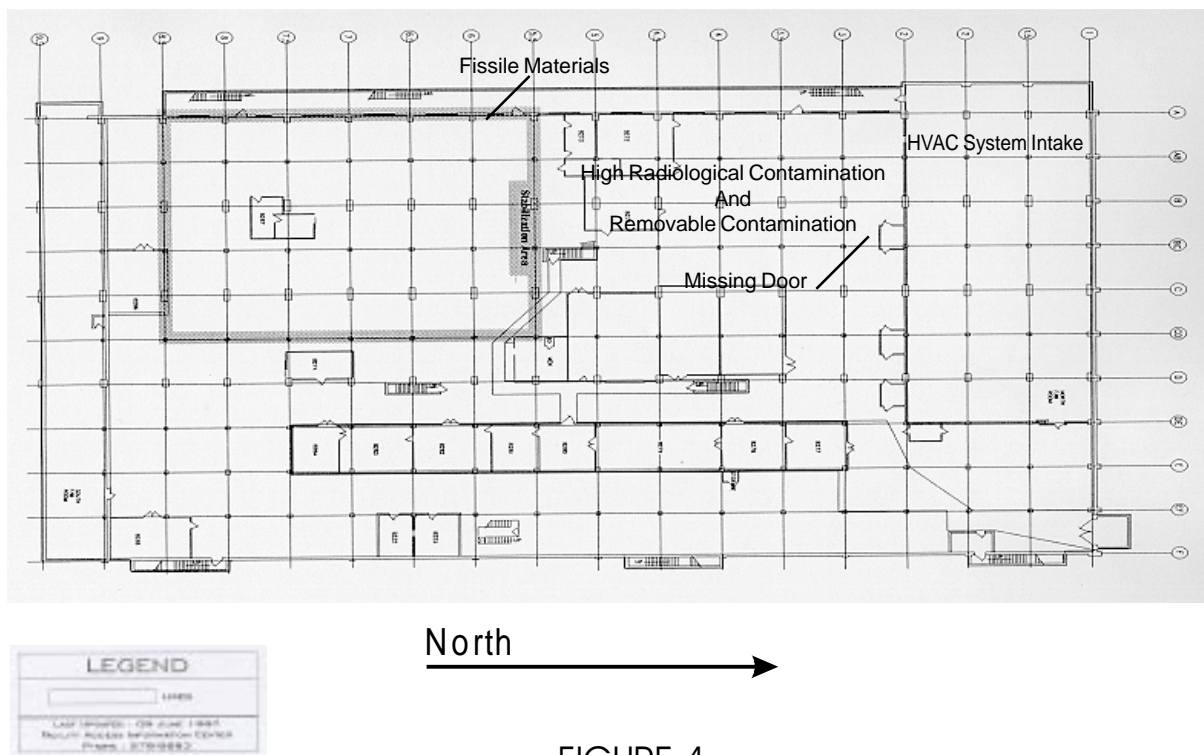
FIGURE 4
BUILDING K-1401
SCHEMATIC-FLOOR AND BASEMENT

Two private companies are leasing and using space within Building 1401, which was originally used for maintenance activities (see Figure 4). However, these buildings have not been fully decontaminated and have not had legacy physical, chemical, and biological hazards characterized and mitigated to facilitate private-sector worker access.

The basement, located under the northwest corner of the building, contains several hazards, including fixed and removable radiological contamination, loose asbestos, contaminated groundwater, and fissile materials. Potential air and water pathways between this basement area and the floor above (including leased building spaces) include the heating, ventilation, and air conditioning (HVAC) system; doors that have been missing since at least 1985; and broken and missing transite (which contains asbestos) air duct panels, which were identified in a 1990 LMES self-assessment as needing repair. Water leaking from building air conditioners was observed on two separate occasions leaking down into high contamination and loose asbestos areas. ETP management took appropriate temporary actions to mitigate these issues when they were identified by the Oversight review team. However, these issues had been reported previously and not corrected prior to leasing these spaces. See text box for other concerns related to Building 1401.
